## 2021 DIKE INSPECTION CHECKLIST

Dike No. (From database*; formerly "Dike GPS No.): 277	Dike Name (From database*): Erie Creek Dike
Diking Authority: Village of Salmo	Local Authority under EPA: Village of Salmo
Water Course: Erie Creek	Dike Section: All
Date Inspected: Sept 16, 2021	Signed:

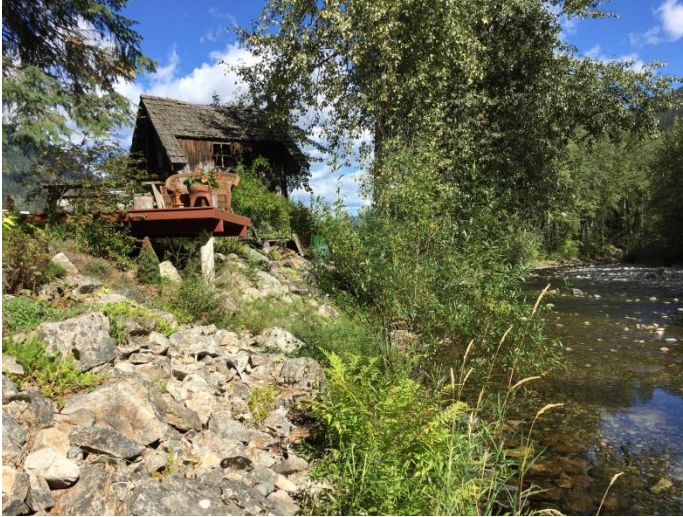
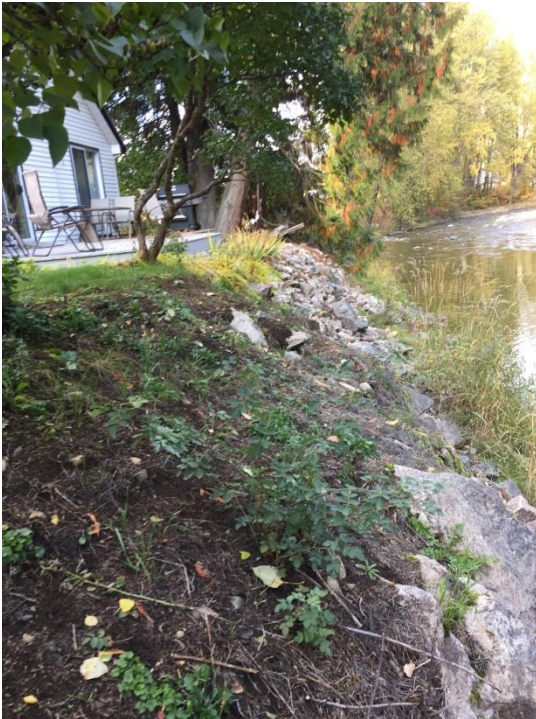
Photo 1 – Location 15

YES	NO ***	N/A
		√	
<p>Location(s)**:</p> <p>Summary of Issues: No Deficiencies Observed</p> <p>Maintenance Recommendations:</p> <p>When will Recommendations be Completed:</p>			
<ul style="list-style-type: none"> <li>Unauthorized construction or activities (excavations, utilities, structures)</li> </ul>	√		
<p>Location(s)**:</p> <p>Loc. 15 – STA 1+300-STA 1+460</p> <p>Loc. 16 – STA 0+500-STA 1+650</p> <p>Summary of Issues: At locations above residents have constructed fences, gardens, and other structures along dike crest. These structures prevent access to the dike for inspections and maintenance.</p> <p>Maintenance Recommendations: Property owners have been advised that structures are prohibited on dike right of way. Property owners have been advised that emergency removal of structures, if undertaken, will be charged to property owners.</p> <p>Coordinate removal with property owners where appropriate.</p> <p>Since the 2020 inspection some structures, particularly behind properties along Ninth Street have been removed although others remain.</p> <p>When will Recommendations be Completed: Ongoing</p>

Unauthorized Construction:

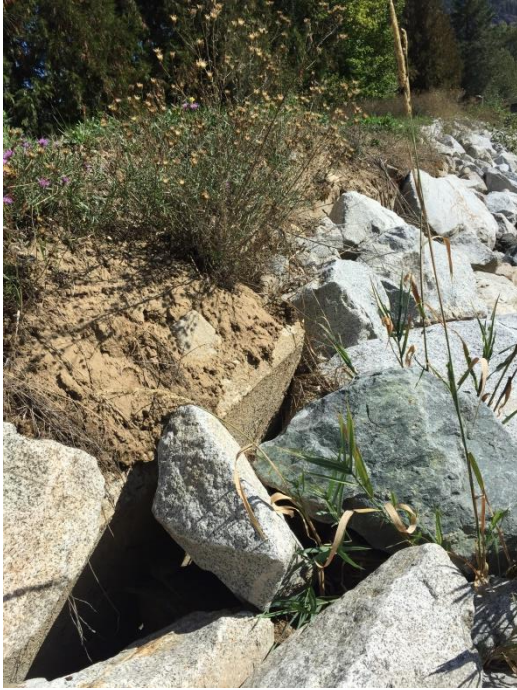
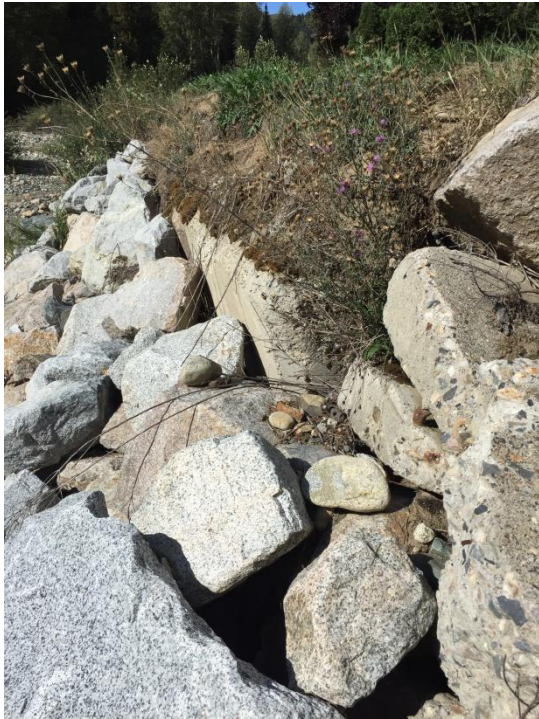
Photo 3 – Location 11

<ul style="list-style-type: none"> <li>Slope instability (slides, sloughs, toe or slope bulges)</li> </ul>	√		
<p>Location(s): Loc. 11 - STA 0+690</p> <p>Summary of Issues: (5) Lock Blocks have slumped and are partially exposed at the crest of the dike and the dike wall is over steep (approximately ¾H:1V slope) at this location.</p> <p>Maintenance Recommendations: The lock blocks should be excavated to locations east and west of the exposed blocks. The alignment of the lock blocks should be reset to the center of the top of the dike and the slope restored to a 2H:1V slope along with installation of geotextile and additional rip rap.</p> <p>When will Recommendations be Completed: This work should be prioritized for the construction season of 2022, budget allowing.</p>

Slumping:

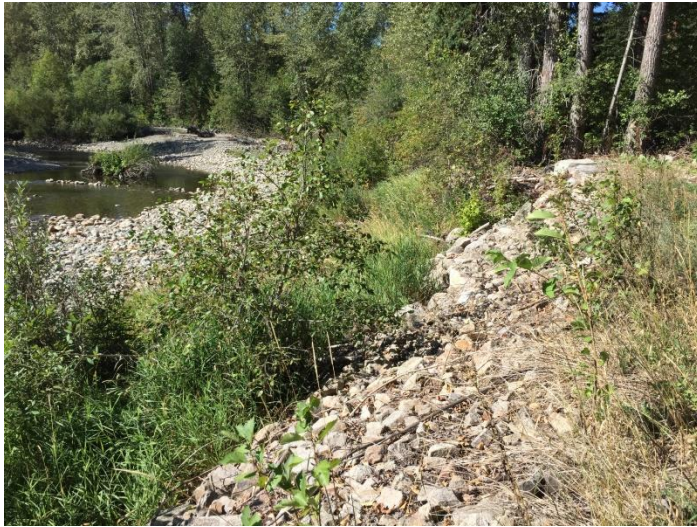
Photo 5 – Location 2

YES	NO <sup>***</sup>	N/A
<ul style="list-style-type: none"> <li>Bank Protection loss or displacement (steep slopes, beaching, scarping, weathering)</li> </ul>	√		
<p>Location(s): Loc. 2 – STA 0+060m (Priority for Maintenance)</p> <p style="padding-left: 40px;">Loc. 8 – STA 0+410m (Priority for Maintenance)</p> <p style="padding-left: 40px;">Loc. 12 – STA 0+825m</p> <p style="padding-left: 40px;">Loc. 14 – STA 0+950 – 1+165M</p> <p>Summary of Issues: Location 2 is currently awaiting permit approval to be corrected.</p> <p>Location 8 is over steep and shows signs of localized erosion.</p> <p>Locations 12 and 14 are stretches of the dike that were never properly armoured.</p> <p>Maintenance Recommendations: Location 2 is anticipated to be resolved before freshet 2022.</p> <p>Location 8 should be prioritized during the next 1-3 year window of dike maintenance.</p> <p>Locations 12 and 14 should be monitored during periods of high water.</p> <p>When will Recommendations be Completed: Ongoing.</p>

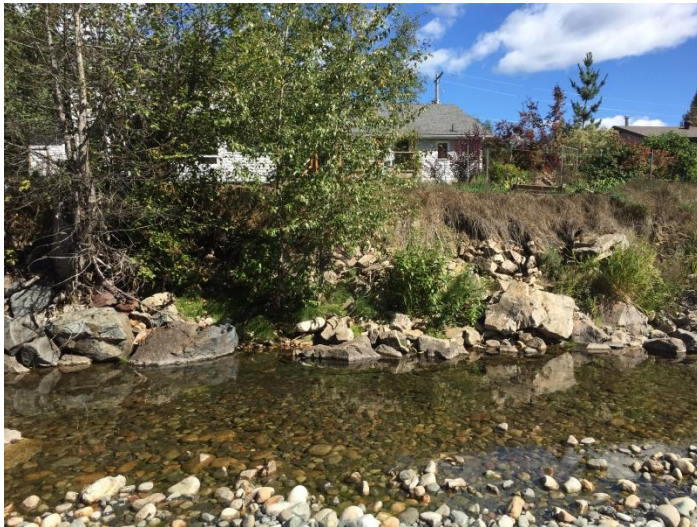
Photo 6 – Location 8

<ul style="list-style-type: none"> <li>Erosion (toe scour, bed degradation, outflanking)</li> </ul>	√		
<p>Location(s): Loc. 8 – STA 0+410m</p> <p style="padding-left: 40px;">Loc. 13 – STA 0+850</p> <p>Summary of Issues: Loc. 8 - Localized erosion of dike armouring</p> <p style="padding-left: 40px;">Loc. 13 - Localized scour beneath concrete apron near highway overpass bridge</p> <p>Maintenance Recommendations: Regular monitoring of locations for further erosion and scour.</p> <p>Location 8 should be prioritized during the next 1-3 year window of dike maintenance and re-armoured per Rip Rap Design and Construction Guidelines, BC Ministry of Environment, Lands, and Parks, March 2000.</p> <p>When will Recommendations be Completed: Unknown</p>

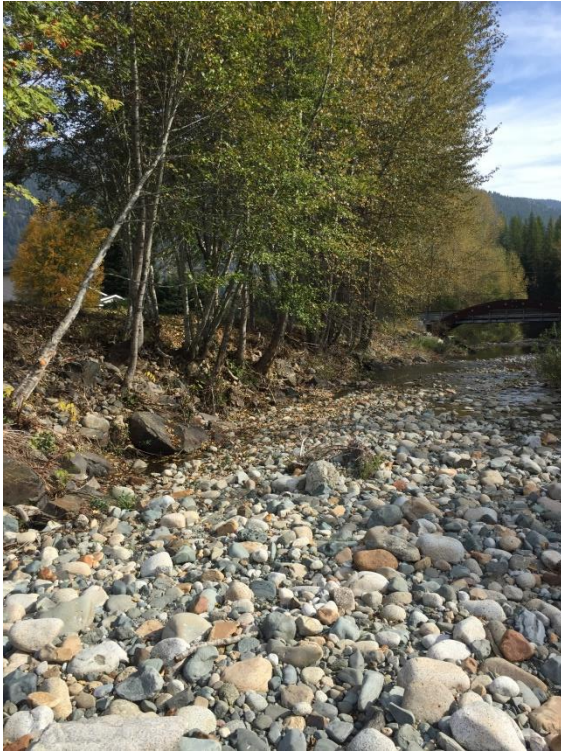
Photo 7 – Location 14

<ul style="list-style-type: none"> <li>Trees in or near dike (within 2m from toe) with potential for uprooting?</li> </ul>	<b>YES</b>	<b>NO<sup>***</sup></b>	<b>N/A</b>
	√		
<p>Location(s): Loc. 8 - STA 0+410</p> <p style="padding-left: 40px;">Loc. 9 - STA 0+470</p> <p style="padding-left: 40px;">Loc. 14 – STA 0+950 – STA 01+165</p> <p style="padding-left: 40px;">Loc. 15 – STA 1+300 – STA 1+460</p> <p style="padding-left: 40px;">Loc. 16 – STA 1+500 – 1+650</p> <p>Summary of Issues: Locations above have trees within 2m from dike toe.</p> <p>Maintenance Recommendations: Trees within 2m of dike toe should be removed.</p> <p>When will Recommendations be Completed: 2022 &amp; Ongoing</p>			
<ul style="list-style-type: none"> <li>Annual/Multi-year vegetation management plan in place? (if yes, attach management plan to the report)</li> </ul>	<b>YES</b>	<b>NO<sup>***</sup></b>	<b>N/A</b>
		√	
<p>If not, please discuss how one will be put into place: No formal plan in place but the Village did undertake significant vegetation management during summer/fall 2021. The Village has expressed the intent to create a formal Vegetation Management Plan in 2022.</p>

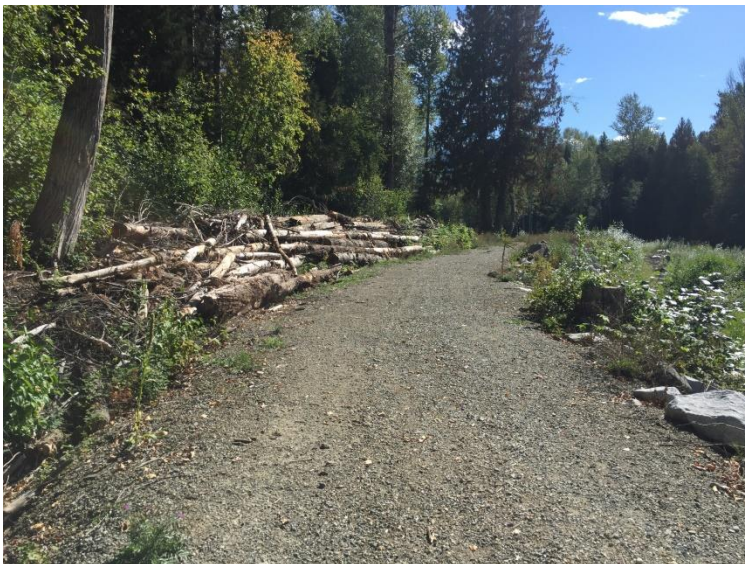
Photo 8 – Location 12

### Vegetation Management:
