2023 DIKE INSPECTION CHECKLIST

Dike No. (From database*; formerly "Dike GPS No.): 277	Dike Name (From database*): Salmo River Dike
Diking Authority: Village of Salmo	Local Authority under EPA: Village of Salmo
Water Course: Erie Creek	Dike Section: Entire Dike
Date Inspected: October 25, 2023	Signed:

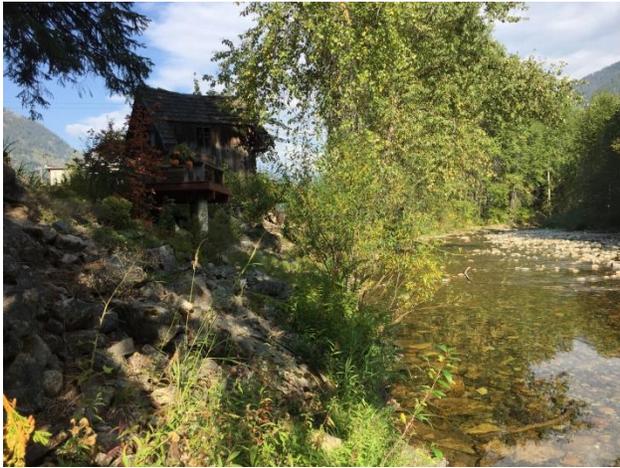
Photo 1 – Loc. 9 – Unauthorized Construction

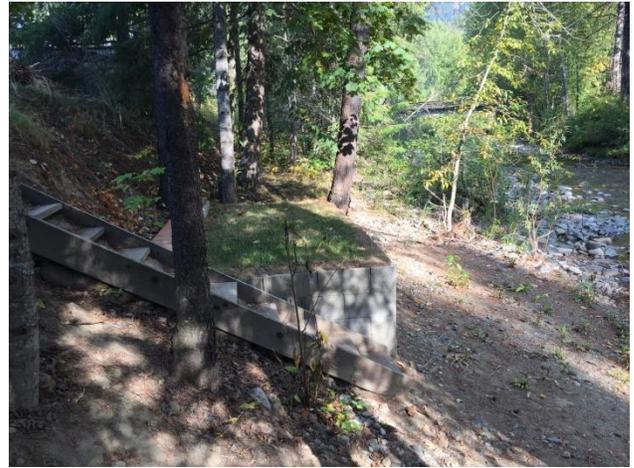
Photo 2 – Loc. 10 – Unauthorized Construction

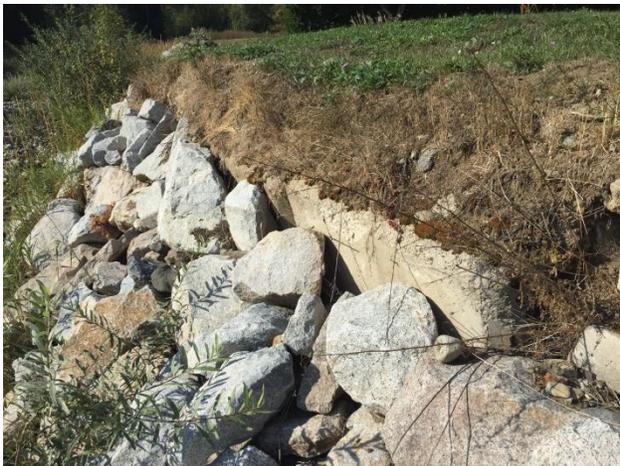
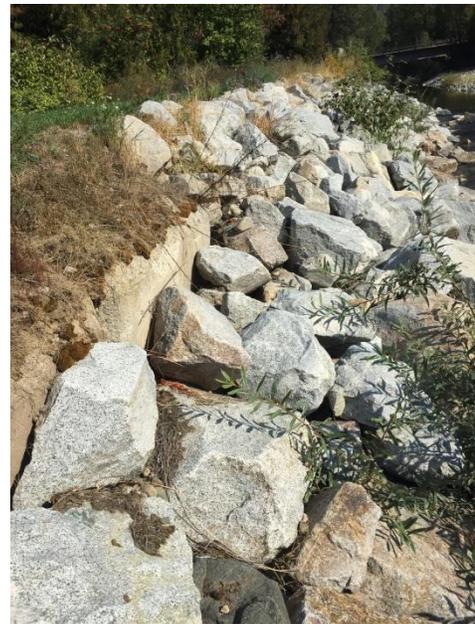
Photo 3 – Loc. 4 – Slumping Lock Blocks

Photo 4 – Loc. 4 – Slumping Lock Blocks

No Action taken yet. This location will become a priority for repair in 2024 ahead of the previous inspection report priority (location 4) noted below.

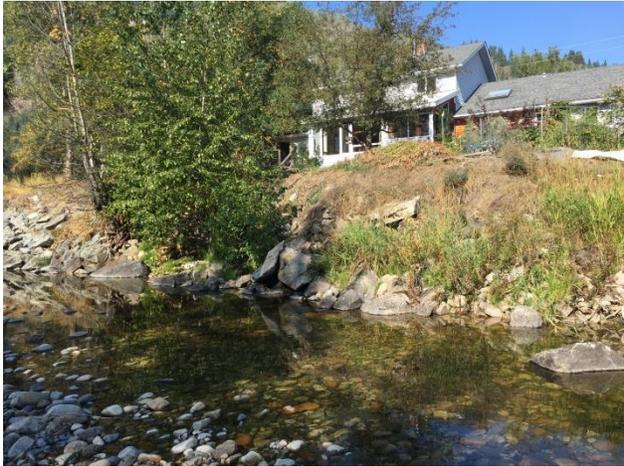
Summary of Issues: Location 2 is poorly armoured, over steep and shows signs of localized erosion.
 Locations 5 is poorly armoured and shows signs of localized erosion.
 Location 6 shows localized scour beneath concrete apron near highway overpass bridge.

Photo 5 – Loc. 2 – Poorly Armoured, Localized Erosion

Maintenance Recommendations: Location 2 should be monitored and prioritized for repair during the next 1-3 year window of dike maintenance.

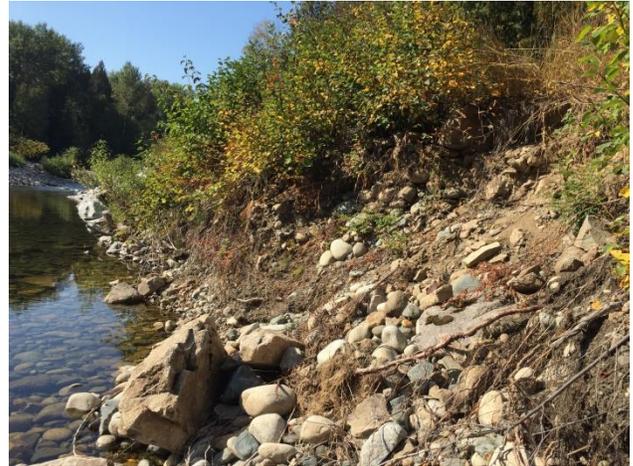
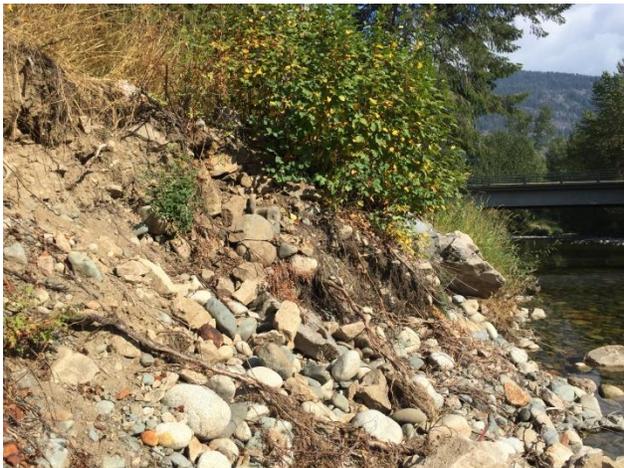
The 2022 dike inspection report identified Location 5 (Station 0+825) as poorly armoured with local erosion. The local erosion has continued resulting in further loss of material and armouring. The dike slope is further over steepened.

Photo 6 – Loc. 5 – Poorly Armoured, Localized Erosion

Photo 7 – Loc. 5 – Poorly Armoured, Localized Erosion

Location 5 should be prioritized for repair during the next 1 year window of dike maintenance.

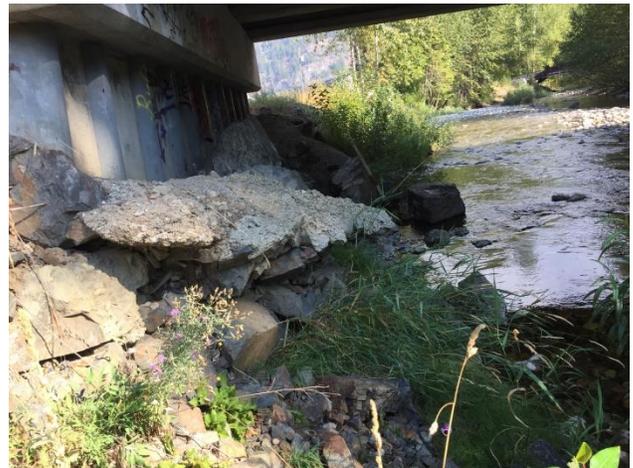
Photo 8 – Loc. 6 – Localized Scour/Erosion

Maintenance Recommendations: Location 2 should be monitored and prioritized for repair during the next 1-3 year window of dike maintenance.
 Location 5 should be monitored and prioritized for repair during the next 1 year window of dike maintenance.
 Location 6 should be monitored. Scour does not appear to have increased over 2022 inspection period.

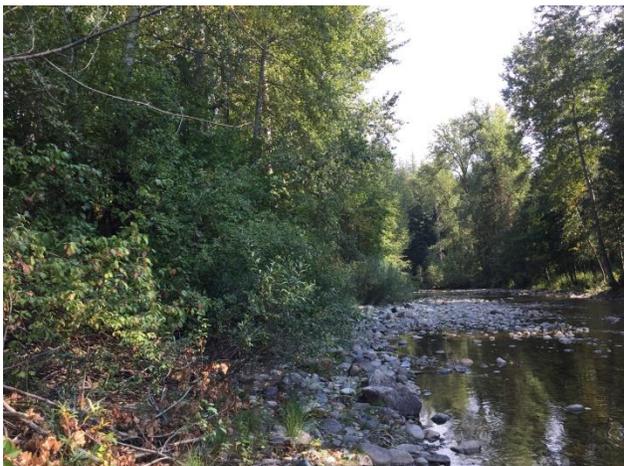
Photo 9 – Loc. 7 – Undersized Armour

Location 7 should be monitored during periods of high water.

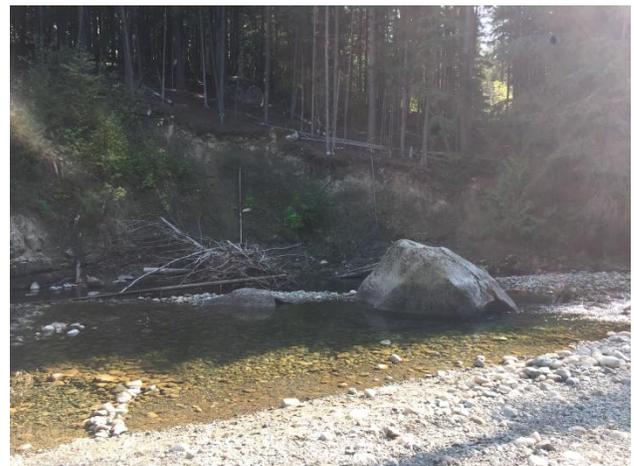
Summary of Issues: Log jam is developing on unprotected bank.

Photo 10 – Loc. 8 – Developing Log Jam

Maintenance Recommendations: Monitor. Cut log jam to +/- 4' sections and allow freshet to clear, as required.

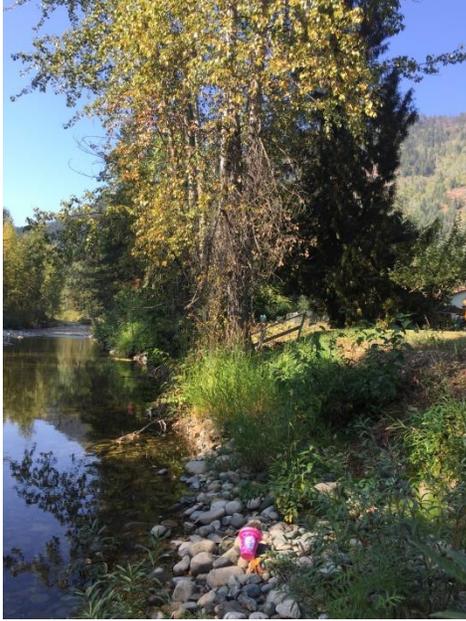
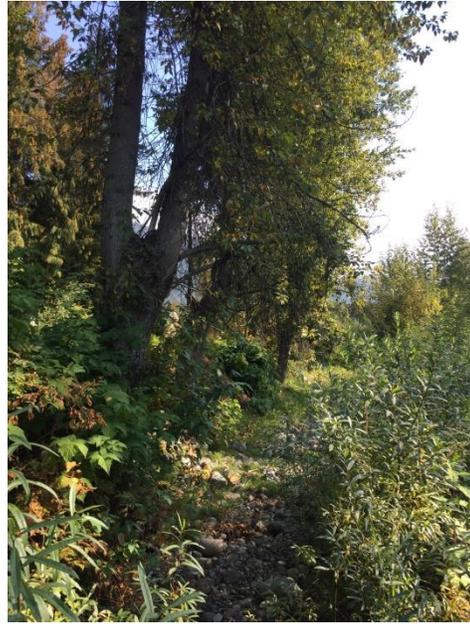
Photo 11 – Loc. 3 – Vegetation

Photo 12 – Loc. 3 – Vegetation

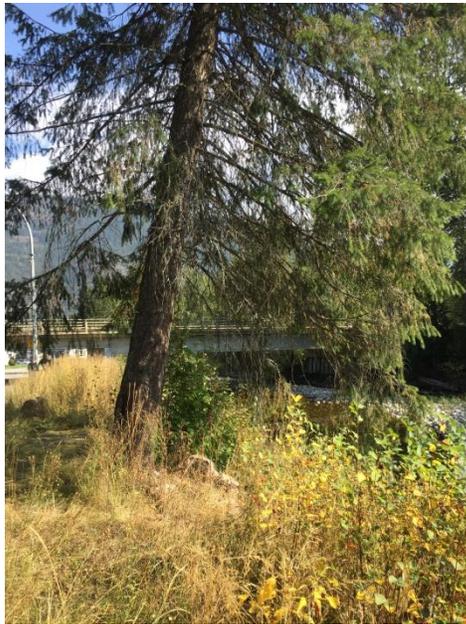
Photo 13 – Loc. 5 – Vegetation

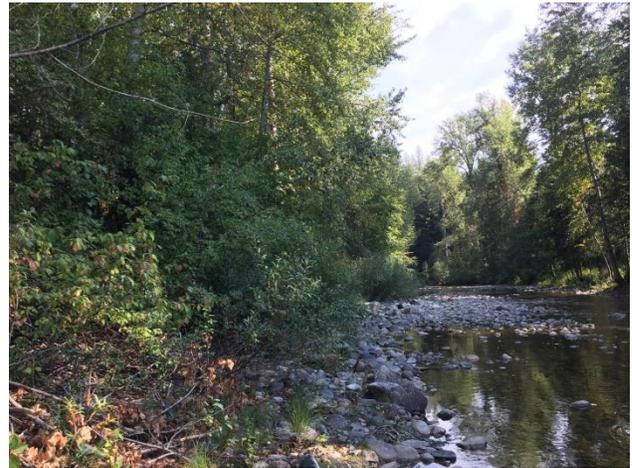
Photo 14 – Loc. 7 – Vegetation

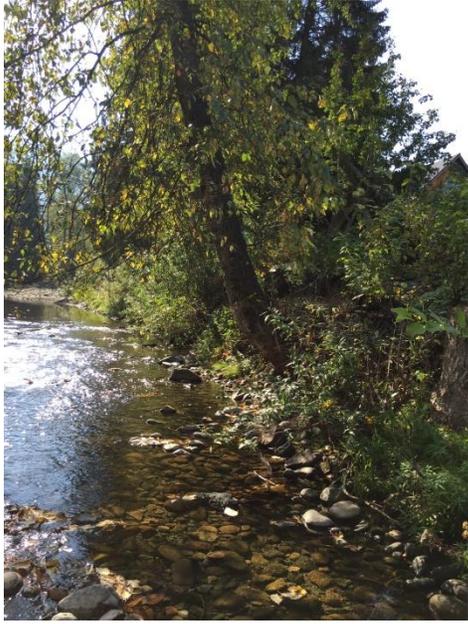
Photo 15 – Loc. 9 – Vegetation

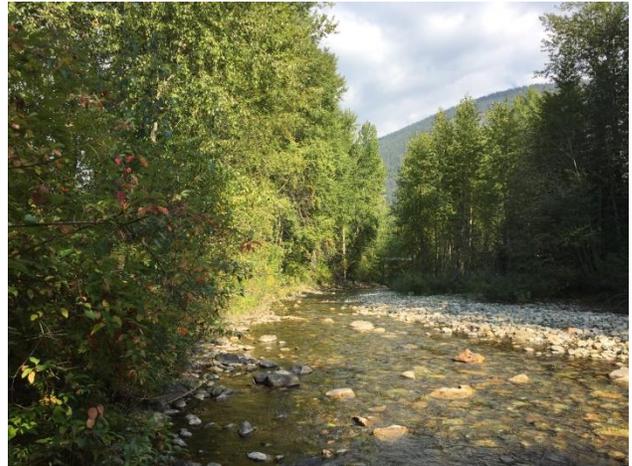
Photo 16 – Loc. 10 – Vegetation
