The Corporation of the Village of Salmo

SPECIAL MEETING

2024 DIKE INSPECTION CHECKLIST

Dike No. (From database*; formerly "Dike GPS No.): 277	Dike Name (From database*): Salmo River Dike
Diking Authority: Village of Salmo	Local Authority under EPA: Village of Salmo
Water Course: Erie Creek	Dike Section: Entire Dike
Date Inspected: October 29, 2024	Signed:

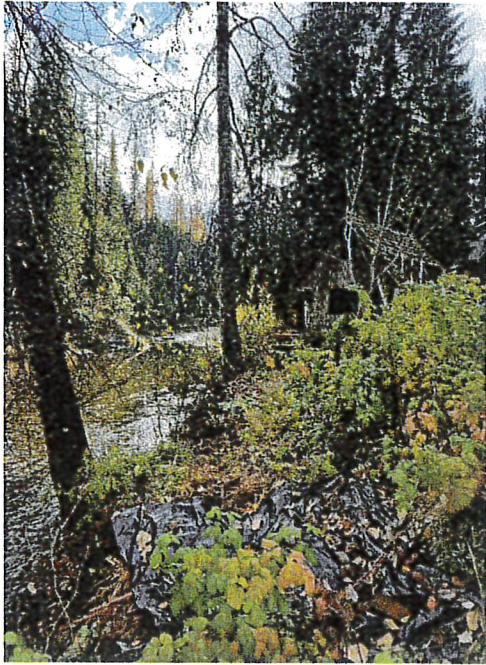
Photo 1 – Loc. 9 – Unauthorized Construction

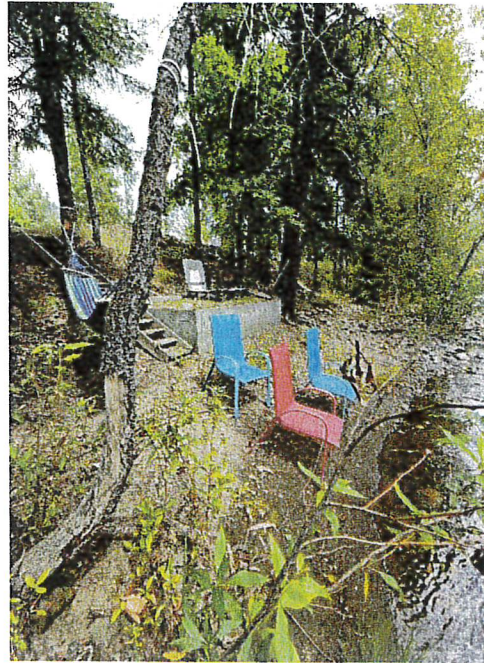
Photo 2 – Loc. 10 – Unauthorized Construction

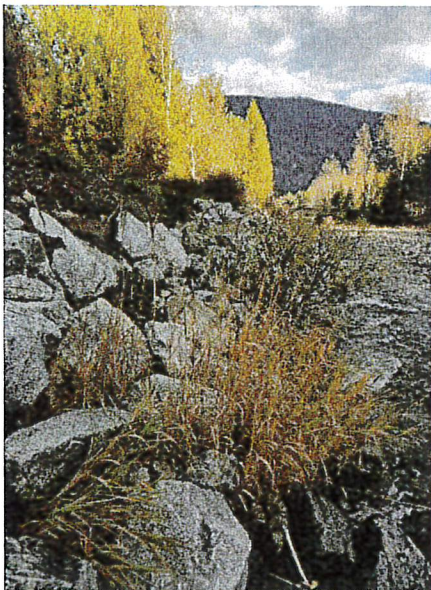
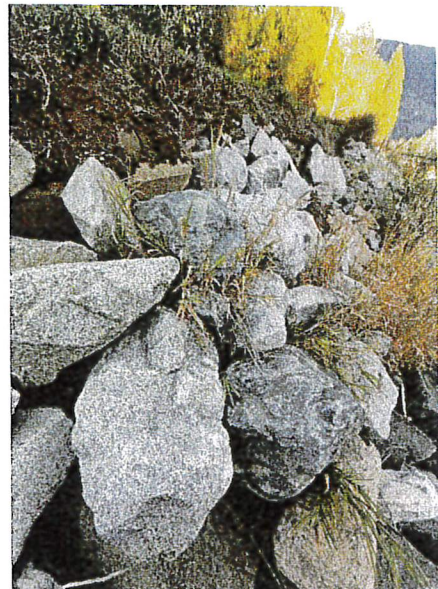
Photo 3 – Loc. 4 – Slumping Lock Blocks

Photo 4 – Loc. 4 – Slumping Lock Blocks

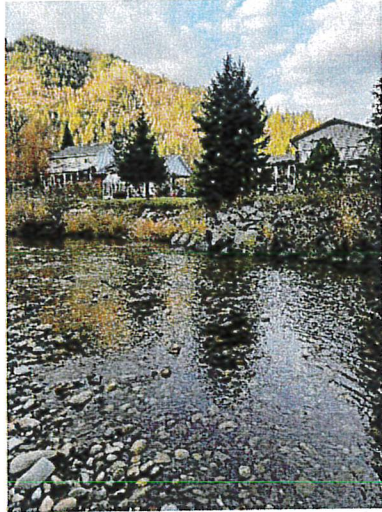
YES	NO***	N/A
<ul style="list-style-type: none"> • Bank Protection loss or displacement (steep slopes, beaching, scarping, weathering) 	√		
Location(s): Loc. 2 – STA 0+410 <div style="margin-left: 40px;">Loc. 5 - STA 0+825</div> <div style="margin-left: 40px;">Loc. 7 – STA 0+950 – STA 1+165</div> Summary of Issues: Location 2 is poorly armoured, over steep and shows signs of localized erosion. Locations 5 is poorly armoured and shows signs of localized erosion. Erosion at Location 5 has continued since the 2023 inspection and this remains the highest priority location along the entire dike. Location 7 is a length of the dike that remains poorly armoured.

Photo 5 – Loc. 2 – Poorly Armoured, Localized Erosion

<p>Maintenance Recommendations: Location 2 should be monitored and prioritized for repair during the next 1-3 year window of dike maintenance.</p> <p>Location 5 should be prioritized for repair during the next 1 year window of dike maintenance.</p> <p>Location 7 should be monitored during periods of high water.</p> <p>When will Recommendations be Completed: Ongoing</p>			
	YES	NO^{***}	N/A
<ul style="list-style-type: none"> • Erosion (toe scour, bed degradation, outflanking) 	√		
<p>Location(s): Loc. 2 – STA 0+410 Loc. 5 – STA 0+825 Loc. 6 – STA 0+850</p> <p>Summary of Issues: Location 2 is poorly armoured, over steep and shows signs of localized erosion. Locations 5 is poorly armoured and shows signs of localized erosion. Location 6 shows localized scour beneath concrete apron near highway overpass bridge.</p> <p>Maintenance Recommendations: Location 2 should be monitored and prioritized for repair during the next 1-3 year window of dike maintenance. Location 5 should be monitored and prioritized for repair during the next 1 year window of dike maintenance. Location 6 should be monitored. Scour does not appear to have increased over 2024 inspection period.</p> <p>When will Recommendations be Completed: Ongoing with location 5 prioritized for 2025 pending budget provisions.</p>

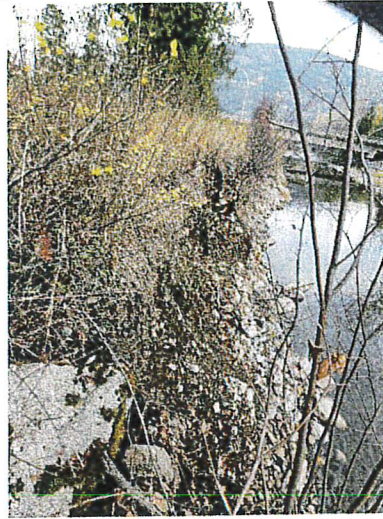
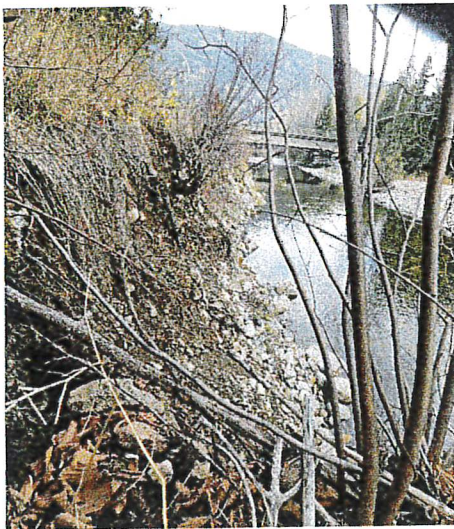
The 2023 dike inspection report identified Location 5 (Station 0+825) as poorly armoured with local erosion. The local erosion has continued resulting in further loss of material and armoring. The dike slope continues to steepen. This is the most active erosion along the dike and is in a vulnerable location next to the Highway 3 overpass.

Photo 6 – Loc. 5 – Poorly Armoured, Localized Erosion

Photo 7 – Loc. 5 – Poorly Armoured, Localized Erosion

No Action taken yet. This location remains the priority for repair in 2025.

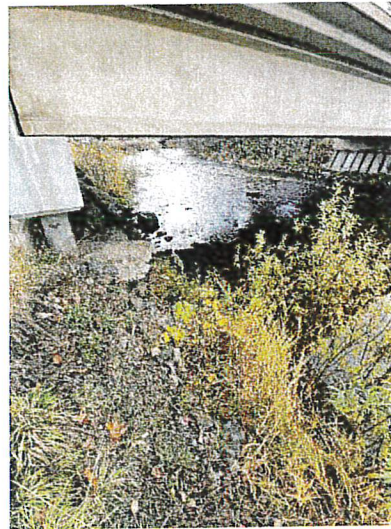
Photo 8 – Loc. 6 – Localized Scour/Erosion

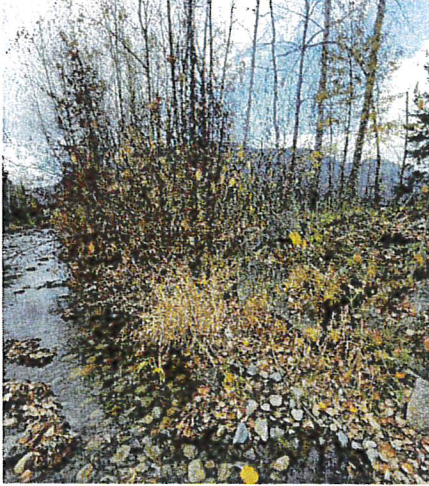
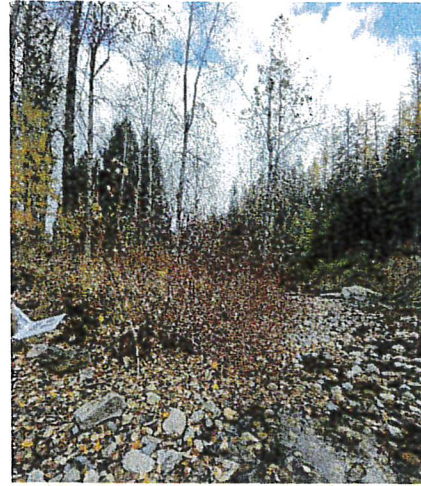
Photo 9 – Loc. 7 – Undersized Armour

Photo 10 – Loc. 7 – Undersized Armour

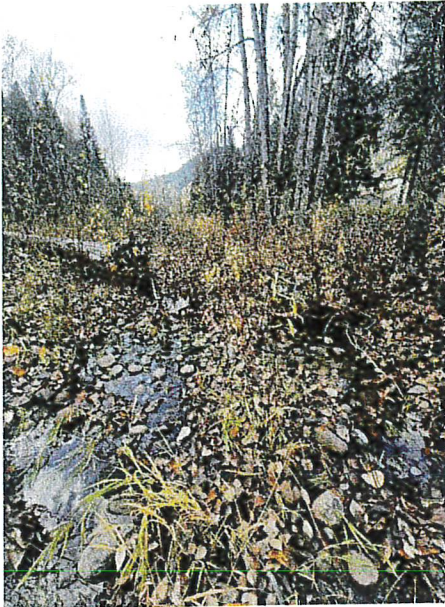
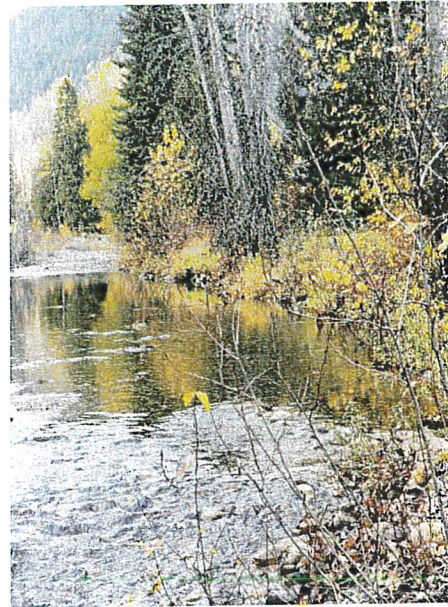
YES	NO***	N/A
<ul style="list-style-type: none"> • Vegetation hampers or prevents access? 	√		
Location(s): Loc. 2 - STA 0+410 Loc. 3 – STA 0+470 Loc. 9 – STA 1+300 – STA 1+460 Loc. 10 – STA 1+500 – 1+650 Summary of Issues: Locations above have significant vegetation that hampers access to the dike, mostly in the form of trees and landscaping in homeowners' backyards. Maintenance Recommendations: Trees and vegetation should be removed. When will Recommendations be Completed: Ongoing			
<ul style="list-style-type: none"> • Vegetation reduces visibility to dike toe on each side? 	YES	NO***	N/A
Location(s): Loc. 2 - STA 0+410 Loc. 3 - STA 0+470 Loc. 5 - STA 0+825 Loc. 7 – STA 0+950 – STA 01+165 Loc. 9 – STA 1+300 – STA 1+460 Loc. 10 – STA 1+500 – 1+650

Photo 11 – Loc. 3 – Vegetation

Photo 12 – Loc. 3 – Vegetation

<p>Summary of Issues: Locations above have trees and vegetation that reduces visibility to either/both toe(s) of the dike.</p> <p>Maintenance Recommendations: Trees and vegetation should be removed.</p> <p>When will Recommendations be Completed: Ongoing</p>			
<ul style="list-style-type: none"> • Trees in or near dike (within 2m from toe) with potential for uprooting? 	YES	NO***	N/A
	√		
<p>Location(s): Loc. 2 - STA 0+410 Loc. 3 - STA 0+470 Loc. 5 – STA 0+825 Loc. 7 – STA 0+950 – STA 01+165 Loc. 9 – STA 1+300 – STA 1+460 Loc. 10 – STA 1+500 – 1+650</p> <p>Summary of Issues: Locations above have trees within 2m from dike toe.</p> <p>Maintenance Recommendations: Trees within 2m of dike toe should be removed.</p> <p>When will Recommendations be Completed: Ongoing</p>			
<ul style="list-style-type: none"> • Annual/Multi-year vegetation management plan in place? (if yes, attach management plan to the report) 	YES	NO***	N/A

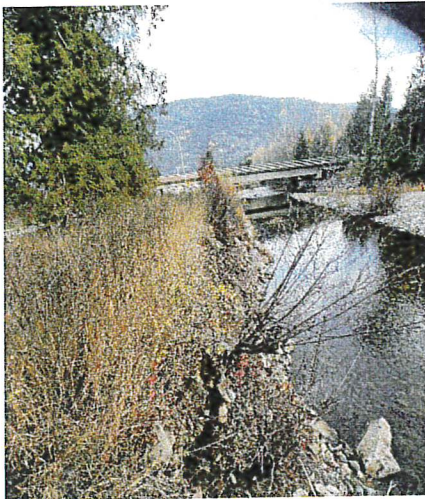
Photo 13 – Loc. 5 – Vegetation

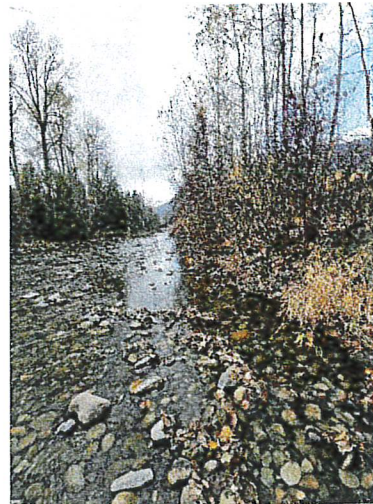
Photo 14 – Loc. 7 – Vegetation

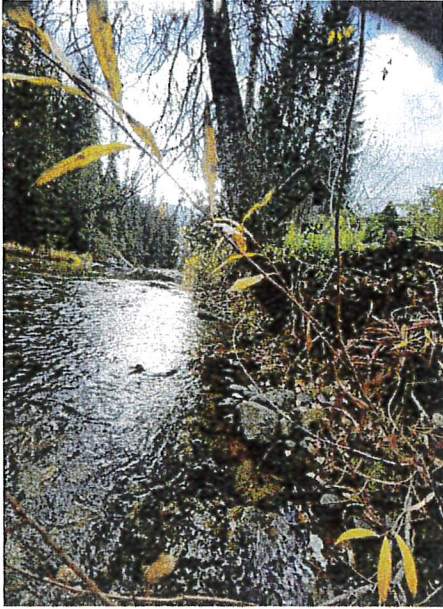
Photo 15 – Loc. 9 – Vegetation

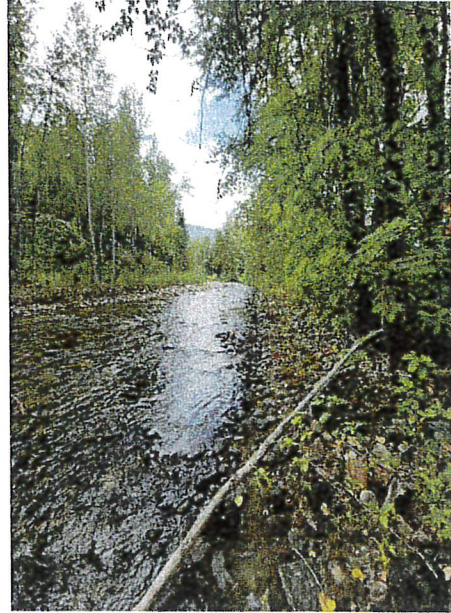
Photo 16 – Loc. 10 – Vegetation
